# AVAILABILITY ASSESSMENT OF HOUSING INFRASTRUCTURAL FACILITIES IN PUBLIC HOUSING ESTATES OF PORT HARCOURT MUNICIPALITY

## Abstract:

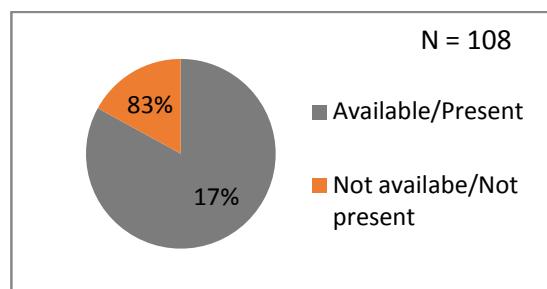
Fig 1 shows the percentage of water supply availability in the estates visited, 17% of estates have water provided and 83% do not have. The subscribers of estates without water supply provide alternative source of water for themselves by sinking boreholes. The main reason for the poor provision of water in the estates can be linked to government's inability to provide districts with water supply from the main truck line.

Fig 1: Availability of Water Supply

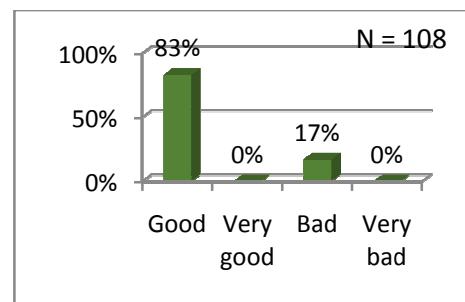
Fig 2 shows the condition of the road network in the study area and it shows that 83% of the road networks are in good condition while 17% of the road networks are in bad condition.

Fig 2: General Road Condition  
Source: Field Survey, 2021

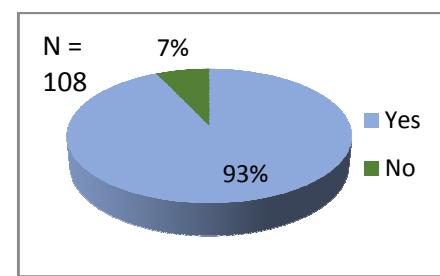
Fig 3 shows the availability of drainage system in the study area, 93% of the respondents said yes there is availability of drainage system in the study area while only 7% said no.

Fig 3: Drainage System in the Estate  
Source: Field Survey, 2021

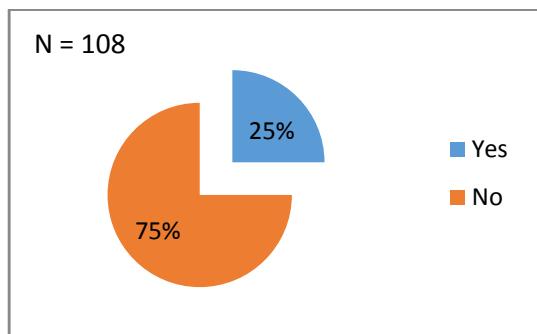
Fig 4 shows whether the drainage is blocked, 75% said No the drainage are not blocked while 25% said Yes the drainage are blocked.

Fig 4: Drainage Blocked  
Source: Field Survey, 2021

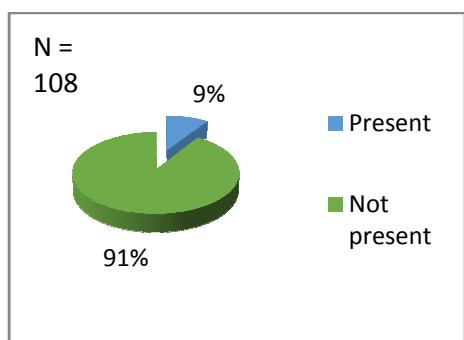
Fig 5 shows the availability of street light in the study area, 9% of the respondents said that availability of street light is present while 91% said that availability of street light is not present.

Fig 5: Street Light  
Source: Field Survey, 2021

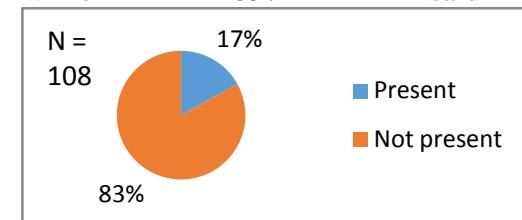
Fig 6 shows the availability of refuse disposal site, 17% of the respondents agreed that the availability of refuse disposal site is present while 83% said no.

Fig 6: The Availability of Refuse Disposal Site  
Source: Field Survey, 2021

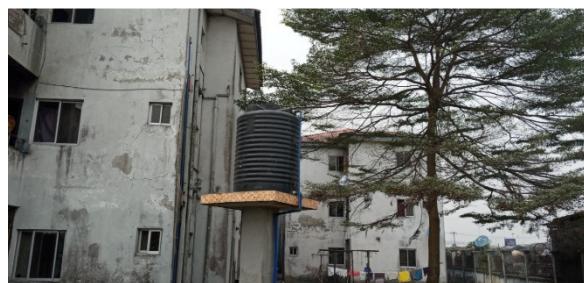
residents complained. The use of private generator happens to be a source of noise pollution in the estate. For water supply, residents rely on their private borehole as there are no public water supply in the estate. Some of the residents said that their apartment is connected to the water main but that there is no water at all and so they get water from private water vendors. This could lead to the spread of water borne diseases as most of the water tanks are not properly washed, water treated and borehole may not be on acceptable limits.

Plate 1 Showing the Private Borehole as a Source of Water Supply  
Source: Field Survey, 2021

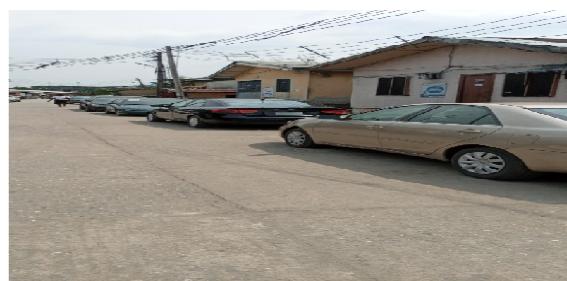
For access road, most of the roads are tarred but with many bad spots and thus needs rehabilitation.

Plate 2: Showing the Road Infrastructural Condition at Aggrey Housing Estate

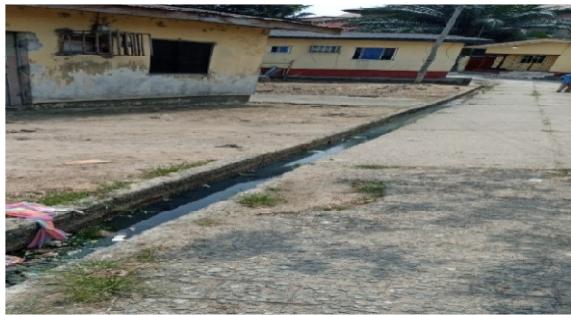
Major parts of all the estates are reticulated with drainage system although, some of these drainages are not flowing due to some factors like the flatness of the area and residents indiscriminate dumping of refuse in the drainage system thus blocking the drainage system.

Plate 3: Indiscriminate Dumping of Refuse in the Drainage in Aggrey Housing Estate
