PERFORMANCE DUE TO FIRE ON BASALT-STRENGTHENED REINFORCED CONCRETE COLUMNS

Mohamed Hassan Abd Elwahab¹, Hala Mamdouh Esmael², Mostafa AbdEl Megied³, Ahmed H. Ali⁴

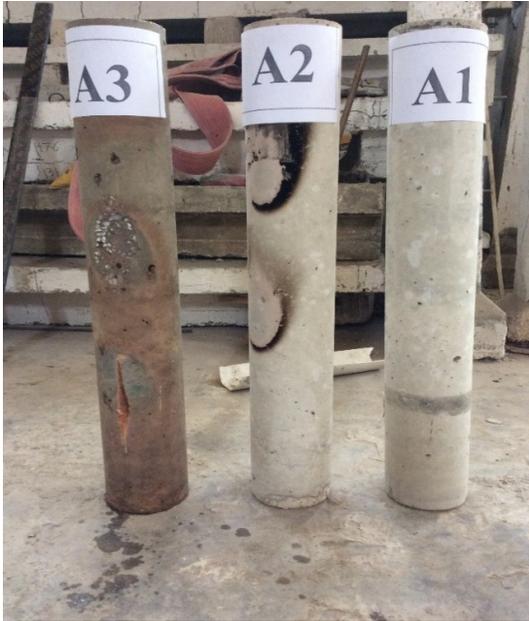
Figure(2): The first group.

The experimental work has been planned to investigate the difference in global behavior between conventional reference short circular columns constructed of normal strength concrete and those columns strengthened with Basalt fiber reinforced polymer. The test measurements include the first crack loads, failure loads, crack patterns, axial deformations, and concrete strains. Therefore, a total of six columns classified into two groups as shown in Table (1). The first group consists of three columns designated by A1,A2 and A3 Where G1 represents the behavior of control column reference specimens without any strengthening as shown in figure (2). The second group represents the Partial Strengthening Basalt Fiber group which consists of three columns B1,B2 and B3.

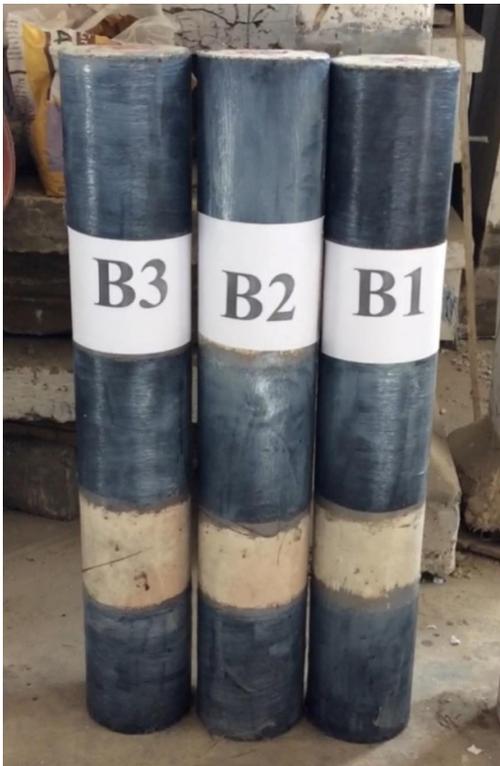
Figure(3): The second group.

B1, B2 and B3: were strengthened with three strips of Basalt Fiber with two layers of 20cm width and spacing of 15 cm as shown in figure (3).

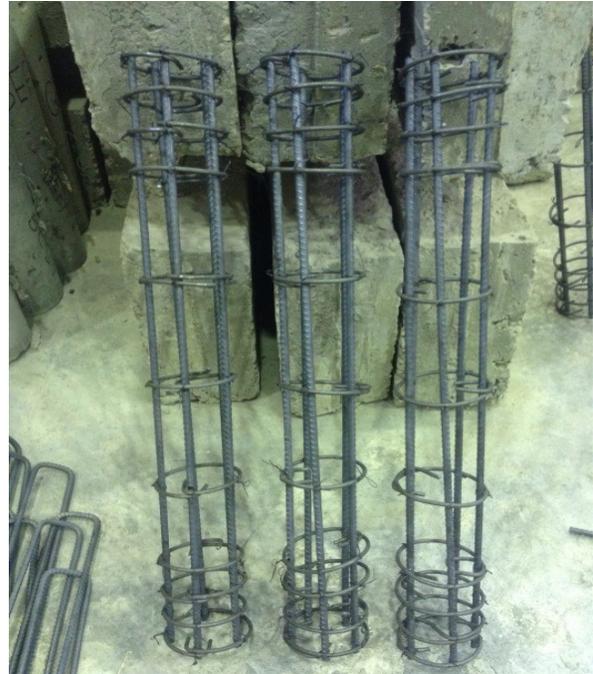
Figure(4):Details of the tested columns

Each column is strengthened with 5Ø10 mm longitudinal fortifying plain bars giving support proportion of 0.022 longitudinal way. For all sections, tied stirrups were given of 11Ø6 mm plain bars. Pitches of stirrups were 5.0 cm at the section closes and 15cm along segment stature. Though the stirrups are accumulated at the segment finishes maintaining a strategic distance from neighborhood disappointment at the segment finishes because of stress focus.

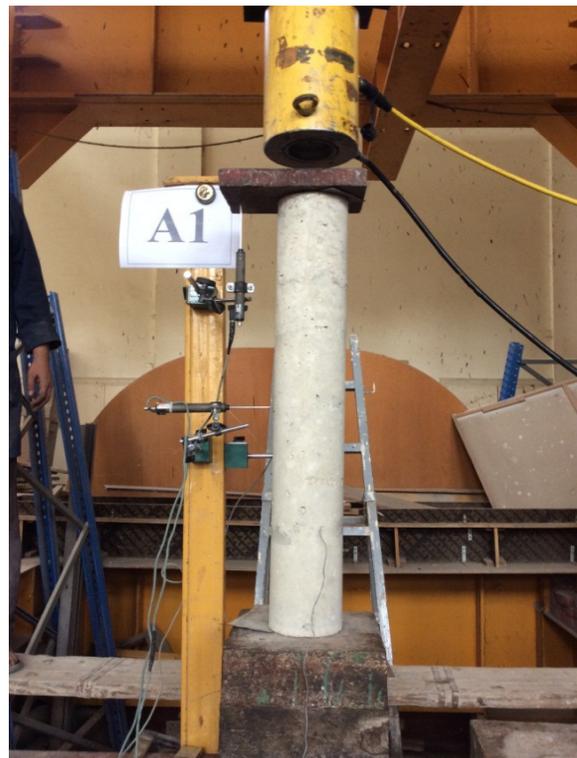
Figure(5):Test setup with a tested column

The electrical strain gauges are used to measure different strains of the columns. One strain gauge is used for each specimen to measure strain of reinforcement, the location of strain gauges at the first third of the column. All columns were tested up to failure in axial compression using universal testing machine having 1200000Newton capacity. The upper head was fitted with seat. Both end surfaces of the columns are capped using gypsum layer to ensure horizontal and smooth surfaces. Care is taken to load the columns axially and reduce any possible eccentricity of the columns. A swivel is placed between the machine and the upper top of the column to ensure uniform loading, as shown in figure (2). The first Group consists of three columns which had tested as control specimens without strengthening to determine the effect of high temperature and way of cooling on the compressive strength of concrete. One column was tested at ambient temperature to determine the maximum load capacity before exposure to high temperature. Two columns were subjected to 500°C temperature for a period of 60 min , one had cooled using water and the other was left to cool at ambient temperature at 25°C. The second group had six columns which were partially strengthened with Basalt Fiber Reinforced Polymers sheets with two layers of 20cm width and 15 cm spacing. One column was tested at ambient temperature to determine the maximum load capacity before exposure to high temperature. Two columns were subjected to 500°C temperature for a period of one hour, one had cooled using water and the other was left to cool at ambient temperature at 25°C.

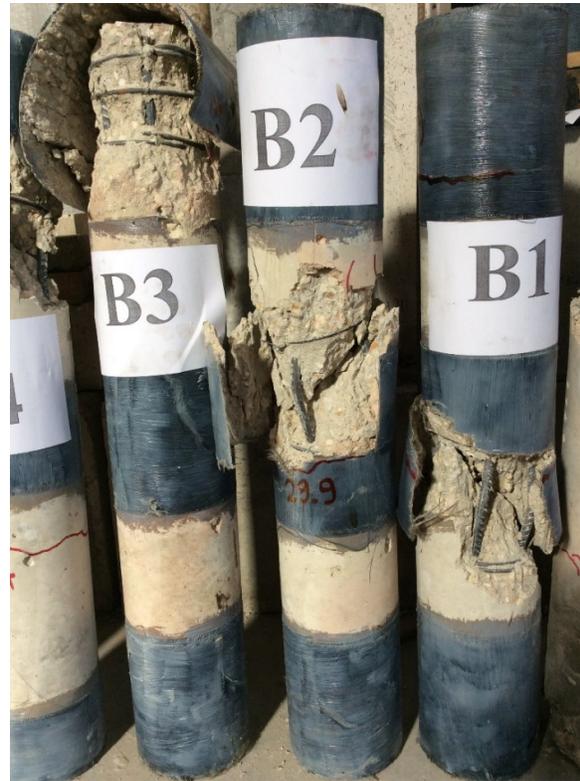
Figure(7): Failure Shape for G2 Basalt Group.

Column (**B1**) one of the basalt fiber group columns which has strengthened partially without exposing to fire. Micro cracks started near the top third of the column and propagated horizontally. The first crack initiated and could be seen at load of 49.90 tons, which represents 84.86% of the peak load. With further loading, The second crack initiated at the middle of the column and could be seen at load of 54.50 tons, The third crack initiated near the lower third of the column and propagated horizontally and could be seen at load of 56.60 tons, The fourth crack initiated and could be seen at load of 57.61 tons at the middle of the column and the complete collapse occurred at load of 58.82 tons, It also shows that the enhancement in the ultimate strength capacity of the column strengthened with partial fibers are 20.1% with reference to **A1** as shown in table(5).

Column (**B2**) one of the basalt fiber group columns which has strengthened partially after exposing to 500 c fire for 60 min and left to cool in ambient temperature. Micro cracks started near the top third of the column and propagated horizontally. The first crack initiated and could be seen at load of 48.04 near the top third of the column which represents 92% of the peak load. With further loading, The second crack is continued the first crack and could be seen at load of 50.14 tons, The collapse occurred at load of 52.02 tons at middle of the column and cut the middle basalt strip, It also shows that the enhancement in the ultimate strength capacity of the column strengthened with partial

fibers are 16.5% with reference to **A2** as shown in table(5).

Coulmn (**B3**) one of the basalt fiber group coulms which has strengthened partially after exposing to 500 c fire for 60 min and had cooled with water. . Micro cracks started the top and bottom slice of the column and propagated vertically. The first crack initiated and could be seen at load of 47.02 near the bottom third of the column which represents 84.88% of the peak load. With further loading, The second crack is continued the first crack and could be seen at load of 51.07 tons, The collapse occurred at load of 55.39 tons at the top of the column and cut the top basalt strip, It also shows that the enhancement in the ultimate strength capacity of the column strengthened with partial fibers are 13.1% with reference to **A3** as shown in table(5).

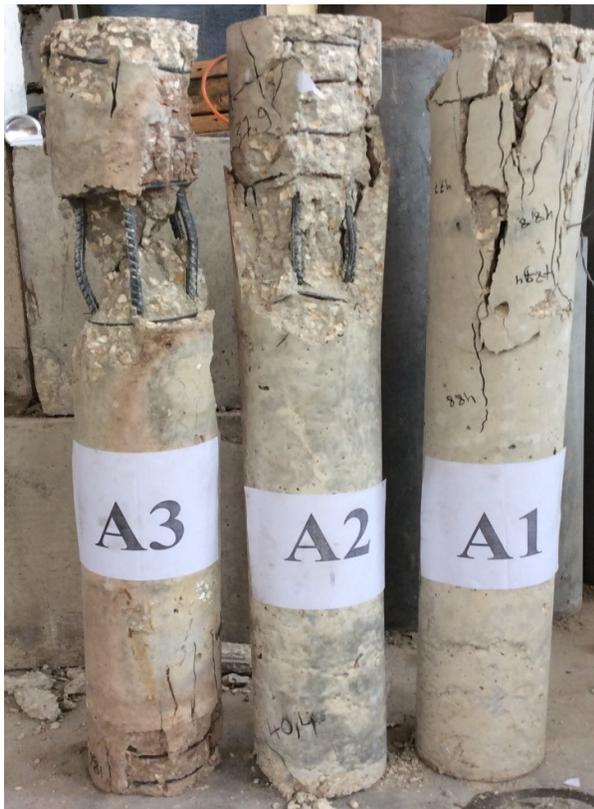
Figure(6): : Failure Shape for G1 Control Group.

Column (**A1**) was tested as a control column at ambient temperature without any strengthening. Micro cracks started near the bottom of the column and propagated vertically. The first crack initiated and could be seen at load of 30.17 tons, which represents 61% of the peak load. With further loading, the second crack initiated and could be seen at load of 42.19 tons at bottom of the column, the third crack initiated and could be seen at load of 45.23 tons at top of the column and spalling of concrete cover started, the fourth crack initiated and could be seen at load of 48.42 tons at bottom of the column it was a horizontal crack and the complete collapse occurred at load of 48.97 tons.

Column (**A2**) was tested as a control column after exposed to fire with a 500 c temperature for 60 min and was left to cool at ambient temperature. Micro cracks started near both the bottom and the top of the column end and propagated vertically. The first crack initiated and could be seen at load of 16.52 tons, which represents 36% of the peak load and spalling of concrete cover started. With further loading, The second crack initiated at the top of the column and spalling of concrete cover started and could be seen at load of 19.23 tons, The third crack initiated and could be seen at load of 37.91 tons at the top of the column and spalling of concrete cover, The fourth crack initiated and could be seen at load of 40.41 tons at the bottom of the column, the complete collapse occurred at load of 44.64 tons.

Column (**A3**) was tested as a control column after exposed to fire with a 500 c temperature for 60 min and had cooled with water. Micro cracks started the

the top of the column and propagated vertically. The first crack initiated and could be seen at load of 19.52 tons, which represents 41% of the peak load and spalling of concrete cover started. With further loading, The second crack initiated at the bottom of the column and spalling of concrete cover started and could be seen at load of 24.63 tons, The third crack initiated and could be seen at load of 38.91 tons at the bottom of the column and spalling of concrete cover, The fourth crack initiated and could be seen at load of 42.41 tons at the bottom of the column, the complete collapse occurred at load of 47.32 tons.
