Energy Dissipation Comparison of Normal Concrete Exterior Beam-Column Connection to that of ECC Connection Under Reversed Cyclic Loading

Muhammad Ishaq*, Zeeshan Ahmad

(Department of Civil Engineering, University of Engineering and Technology, Peshawar, Pakistan)

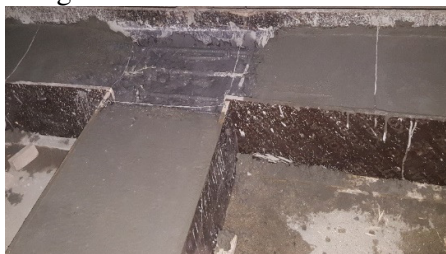
Fig 03. (a) ECC pouring in joint zone

Figure 3 Portion of Exterior Beam-column Joint, a). ECC in joint, b). ECC joint and adjacent area

The mixing steps for normal concrete was carried out by small mechanical mixture machine while ECC mixing was carried out manually. To gain proper workability of fresh concrete and ECC, the mixing was thoroughly done for two minutes of NC and for five of ECC. After homogeneous mix, the concrete was supplied to fabricated cages of steel and formwork shown in Figure. 02 (a & b). The ECC were poured only in joint and connection zones of specimens SJ-ECC core and SJ-ECC connection as shown in Figure. 03 (a) and (b) respectively. While the rest of specimens were poured with normal concrete. The concrete was poured in three layers in all specimens and thoroughly compacted through vibrator except the portion of joint and connection were separated by plates of steel. The specimens SJ-ECC joint zone and SJ-ECC connection zone were poured with ECC. Concrete and ECC were poured in the same time, while at the end ECC and concrete boundaries were carefully intermingled by vibrator. After 24 hours of casting, the specimens were covered by water retaining cloths. The water curing of specimens was carried out for 28 days to gain the design strength.

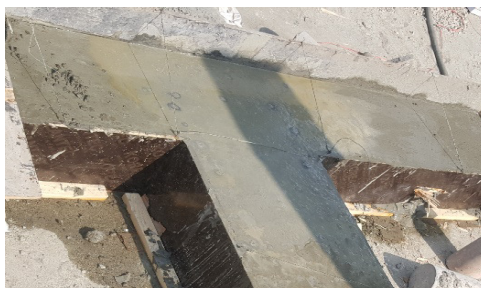
Fig. 03 (b) ECC pouring in connection zone/plastic hinge zone

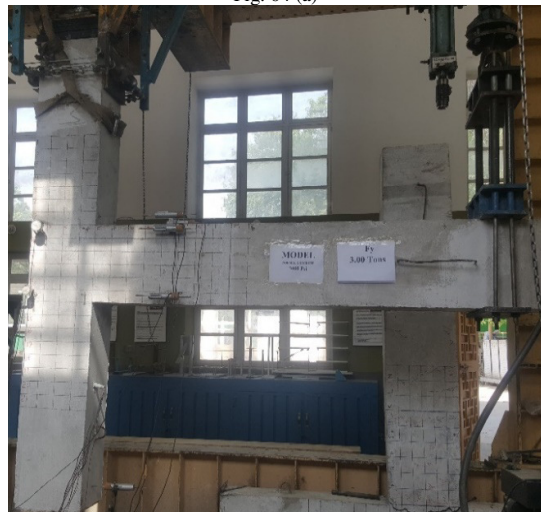
Figure 4 Testing Program, a) schematic setup, b) Lab setup

Test specimens were strongly fit in the testing frame for testing. Figure. 04(a) and (b) presenting schematic and original lab setup respectively. The load cell used for cyclic load action at the tip of beam has capacity of 245 kN. The cyclic load action was applied at 7.5 ft. distance from the face of the support as shown in Fig. 04(a). A constant axial compressive load of magnitude 384 kN (15% of total axial compressive load) was applied to column by another load cell.

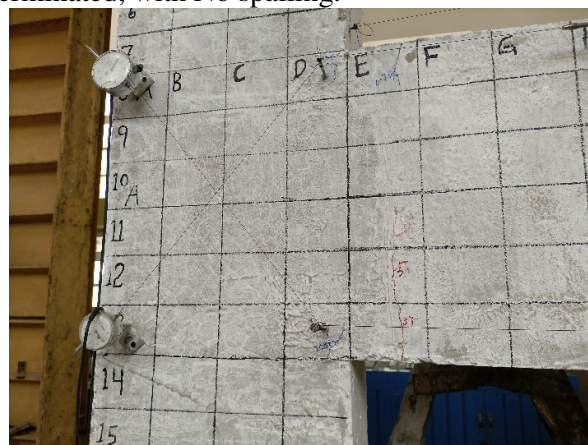
Figure 5. Crack pattern of specimen SJ-ECC-I, a). West face of the specimen, b) East face of the specimen

The specimen faces were defined with West and East faces for recording of the crack pattern and failure mode. The reverse cyclic load was applied at in increment of $0.25F_y$ ($F_y = 29.43 \text{ KN}$) and increased to till $2.25 F_y$ and then to F_y . No crack was observed at first but minor cracks appeared at the $2.25F_y$ and F_y loading stages. After this control displacement of 0.75% of the 2438.4 mm was applied and first diagonal micro craze were observed. Similarly, control displacement was further increased to till 5.5% of the total drift of 2438.4mm and overall crack pattern was observed and noted as shown in Figure. 05 (a & b) of the west and east face of the specimen. After commencement of spalling, the test was terminated at 5.5% drift ratio.

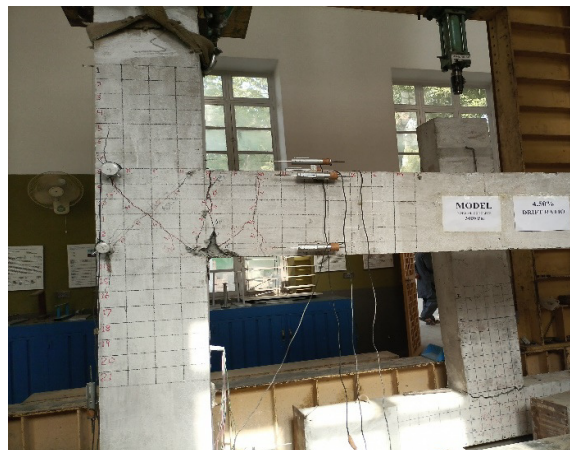
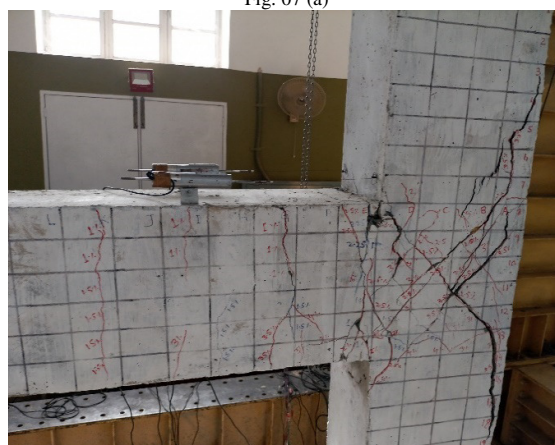
Figure 7Crack pattern of specimen SJ-NC, a). West face of the specimen, b) East face of the specimen

the 2.25Fy and Fy loading stages. After this control displacement of 0.75% of the 2438.4 mm was applied and first diagonal micro crack were observed. Similarly, control displacement was further increased to till 4.5% of the total drift of 2438.4mm and overall crack pattern was observed and noted as shown in Figure. 07 (a & b) of the west and east face of the specimen. After commencement of spalling, the test was terminated at 4.5% drift ratio.

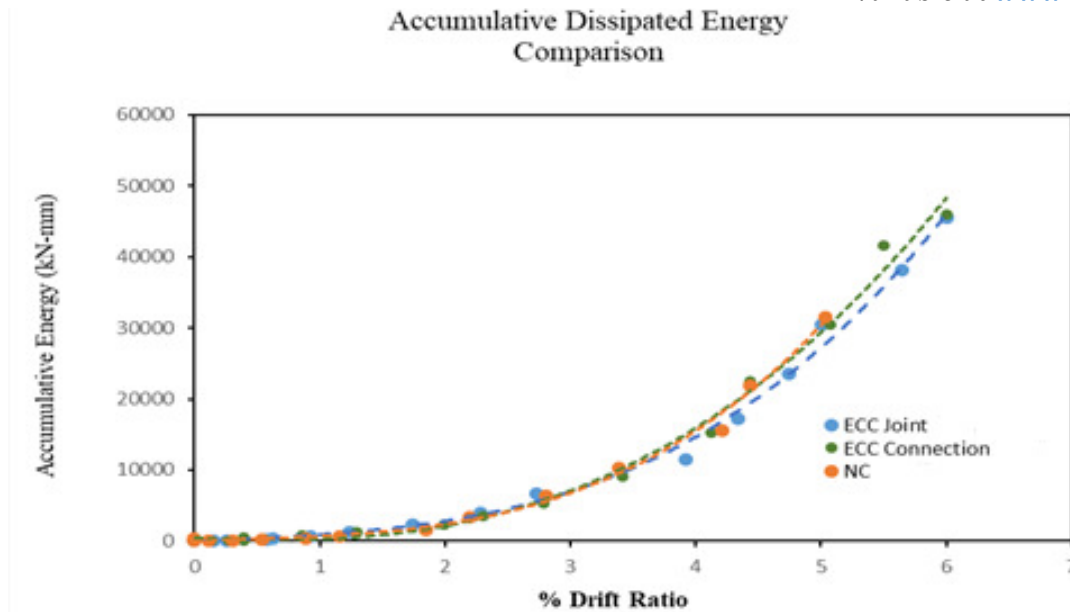
Energy dissipation of all models was calculated from fore-deformation relationship curves by numerical integration. The relationship of accumulative dissipated energy per cycle and drift is shown in Figure 08. Drift is plotted on the x-axis while accumulative dissipated energy on the y-axis. The comparison of the three specimens also shown graphically in figure 08. The blue and green colour curves represent the ECC incorporated specimens while the orange colour represent the NC specimen. Accumulative energy dissipation comparison for model SJ-ECC-I, SJ-ECC-II and SJ-NC were 45461

Figure 8 Accumulative Dissipated Energy Comparison of SJ-ECC-I, SJ-ECC-II, SJ-NC

KN-mm, 45940 KN-mm and 31505 KN-mm respectively.

1. Incorporation of ECC in the joint zone instead of NC, enhanced the performance of beam-column joint in term of ductility, shear resistance, damage tolerance and energy dissipation.
2. Overall cumulative dissipated energy of model SJ-ECC-I and SJ-ECC-II were increased by 44.5% and 45.82% respectively to SJ-NC. Hence, the result show that ECC has superior energy dissipation capacity relatively NC.
3. Model SJ-ECC-I and SJ-ECC-II test were almost terminated at 5.5% drift ratio, inspite the models joint fibers were in intact and were in good conditions but model SJ-NC was in the worse condition at 4.5% drift ratio. Hence, ECC was more damage
