Rehabilitation Program of Lambiki River: A Proposed Aeration Design and Sustainable River Management Plan in Brgy. Sta. Teresa 2nd, Lubao, Pampanga

Abstract:

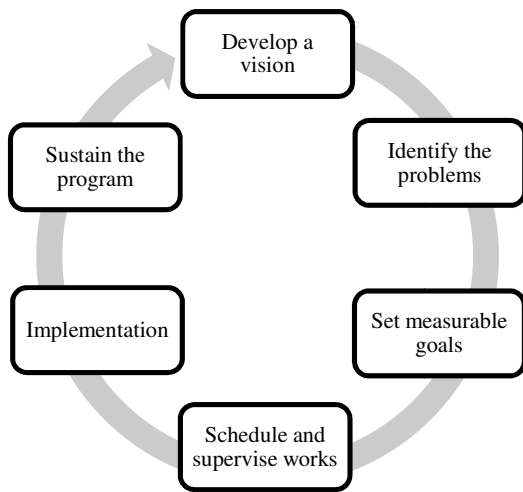
Fig 7 Sustainable River Management Plan Flow-chart

Effective communication of the river management plan to all community members is essential in garnering their participation and cooperation. The plan will be elaborated in a visual representation outlining the stages of the structural design program, encompassing vision development, issue identification, goal setting, scheduling, oversight, implementation, and program maintenance. This visual aid, presented in Figure 7, serves as a guide for the structural restoration endeavour. The development of this visual aid was influenced by the works of Philips and Bennett [34].

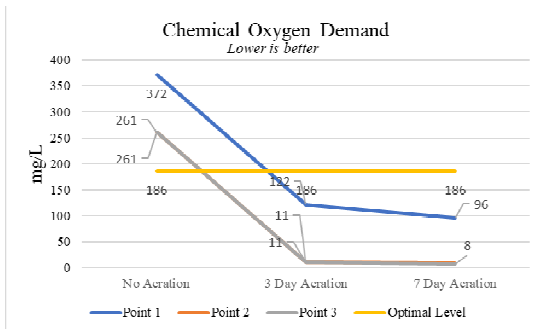
Fig 10 Chemical Oxygen Demand (COD) in mg/L

The COD test of the Lambiki River water revealed a decrease in COD levels after both three and seven days of aeration (Figure 10). This suggests that the aeration process effectively improves water quality by reducing organic matter pollution, aligning with research findings by Li and Liu [37].

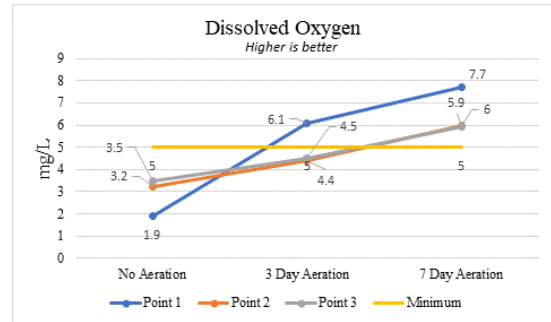
Fig 11 Dissolved Oxygen (DO) in mg/L

The prototype aeration system significantly improved DO levels in the Lambiki River (Figure 11). Initial DO levels were below the DAO 2021-19 minimum for classification C. After three days of aeration, DO levels increased, particularly at point 1, indicating enhanced support for aquatic life. By the seventh day, all three points surpassed the minimum DO level, demonstrating the effectiveness of aeration in improving water quality.
