A Proposal Design of Stone-Pitched Retaining Wall as a Countermeasure for Soil Erosion in San Agustin Creek, San Agustin, San Fernando, Pampanga

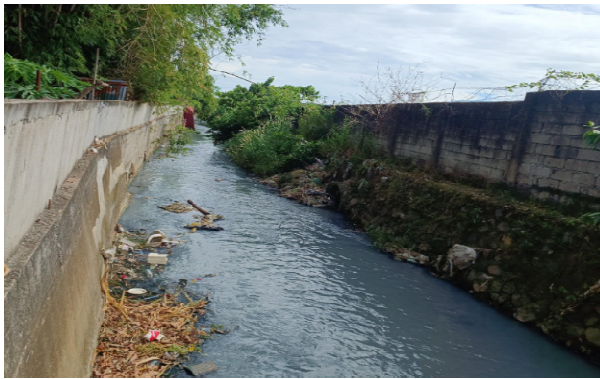
Fig. 3 Slope Rehabilitation Project in Selected Areas of the San Agustin Creek, City of San Fernando, Pampanga

A selected portion of the slope of San Agustin Creek which is shown in Figure 3 was stabilized by a retaining wall. Specifically, the retaining wall was constructed within Saint Augustine Village, Barangay San Agustin, City of San Fernando, Pampanga.

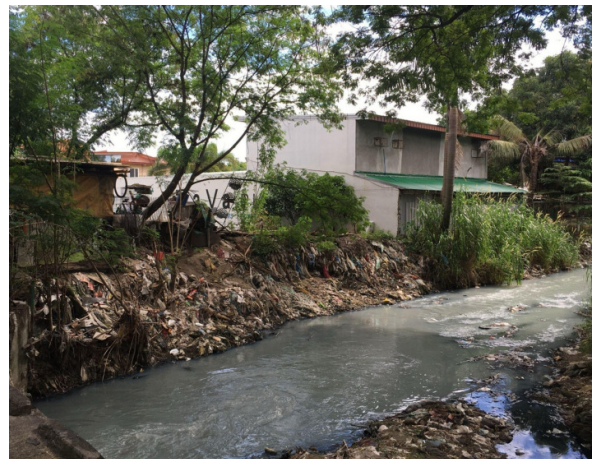
Fig. 5 San Agustin Creek in Ramar Village, Barangay San Agustin, City of San Fernando, Pampanga

Figure 5 shows the slope condition of the creek. Slope stability is the capacity of a slope or embankment to sustain varied stresses without severe deformation or failure [5]. Erosion and landslides, two common natural disasters, may accelerate soil degradation and loss. Rainfall frequently causes such dangers because it affects the physical stability and soil composition [18]. Soil

The bare slope along San Agustin Creek in Ramar Village, Barangay San Agustin, City of San Fernando, Pampanga, is undergoing bank deterioration which is a result of natural erosion processes intensified by heavy rainfall and its connection to the contiguous waterway linked to the Pampanga River Basin. Hence, implementing slope protection is imperative to maintain the ecological integrity of the creek [19].

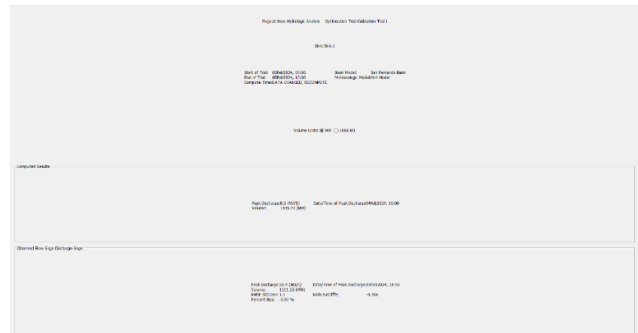
Fig.11 Final Simulation Summary of Results

The final simulation shown from the HEC-HMS in figure 11 suggests a minimal bias in predictions and acceptable variability in observed data. Thus, researchers can apply the observed flow of the model for simulating the Hydraulic Model of the creek in HEC-RAS.

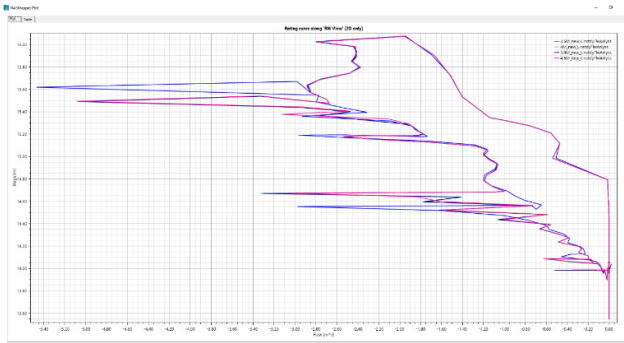
Fig. 12 Rating Curve Along 'RW View'

Figure 12 shows that when the water level is either rising or falling due to flow rate changes, the curve goes up or down. Based on the result, the 4m height has the steadiest flow among the tested heights, followed closely by 3.5m, 4.5m, and 3.8m. Generally, the Rating Curve Along 'RW View' plot clear things up on how water level reacts to flow rate varies, showing the relation between these two factors clearly.

All throughout the process, the 4m wall height consistently produced the steadiest results, with minimized total volume collection and uniform flow behavior. It also succeeded various aspects like the rating curve, volume accumulation, and water surface elevation. The 4m retaining wall height stands out as the ideal option for reducing flood risk and controlling flow due to its stability, less erosion risk, and unsteady flow patterns.

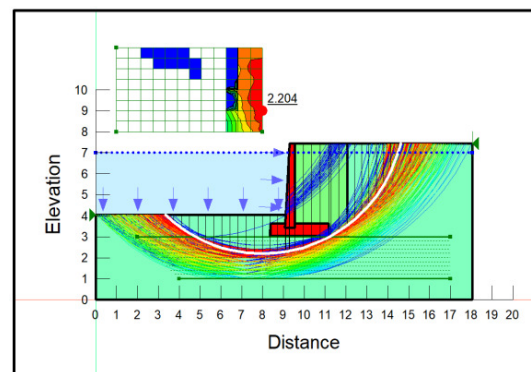
Fig. 15 Results of the Retaining Wall in GeoStudio

The result of the design that has been tested is 2.204, known as the Factor of Safety that is shown

in figure 15. The Department of Public Works and Highways (DPWH) Blue Book stated that, a safe and accepted design of retaining wall should have greater than 1.2 Factor of Safety. This figure also shows all slip surfaces with different color lines that refer to sliding which may occur. All slip surfaces hold greater a value Factor of Safety than the critical slip surface; therefore, it is considered safe.
