INNOVATIVE STRATEGIES FOR RESTORATION OF RCC STRUCTURE OF ACID STORAGE TANKS IN  
PROCESS INDUSTRIES - A CASE STUDY

#### 4.0 A Case Study of Health Assessment of RCC structure Acid Storage Tanks is discussed;

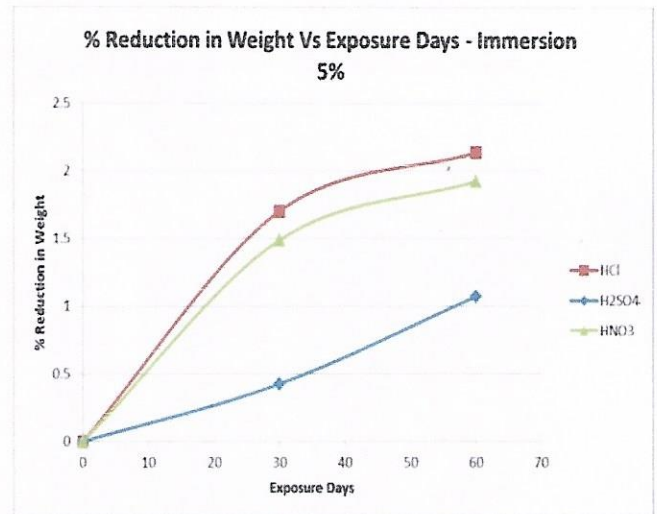
Fig. 1 : Graphical representation of % Reduction in Weight Vs Exposure Time when cubes are immersed in 5 % Acid

The above graph represent the % reduction in weight of concrete cubes for 5 % concentration of different acids when subjected to complete immersion for 30 days and 60 days. At higher exposure period of 60 days, maximum reduction of around 2.1 % is observed. when concrete cubes are immersed in Hydrochloric acid, also at lower exposure period of 30 days, maximum reduction of 1.7 % is observed for Hydrochloric acid.

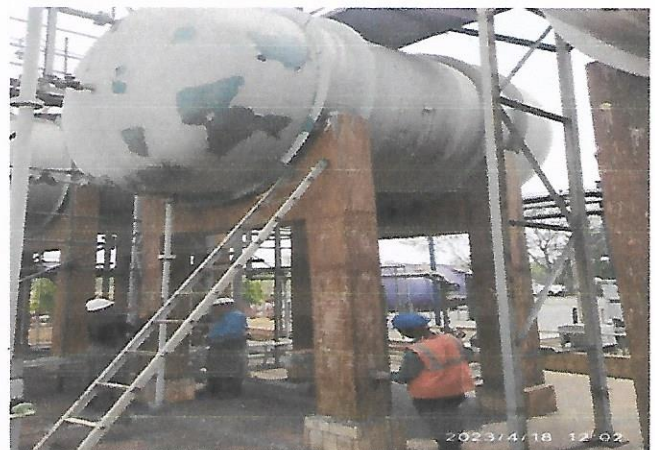
Fig. 5: Cracks & Porosity found in TG deck Pedestal

6.1.1 Providing and injecting Super Low viscosity Epoxy injection grouting through 12mm dia NRV Nozzle inserted in to the concrete by at operating pressure of 4.5 to 5.5 Kg/cm<sup>2</sup> using pressure pump for strethening of core concrete and making concrete alkaline.

6.1.2 Providing, mixing and applying chemically modified Polymer Plaster on concrete surface average depth of 10mm.

6.1.3 Acid resistant Tiles fixing on concrete surface  
Providing acid resistant treatment on horizontal & vertical surfaces by laying acids resistant bricks of 230 x 115 x 38 mm with min 6 mm thick under bed of potassium silicate based mortar, raking of joints & filling the gaps/joints with acid resistant epoxy mortar

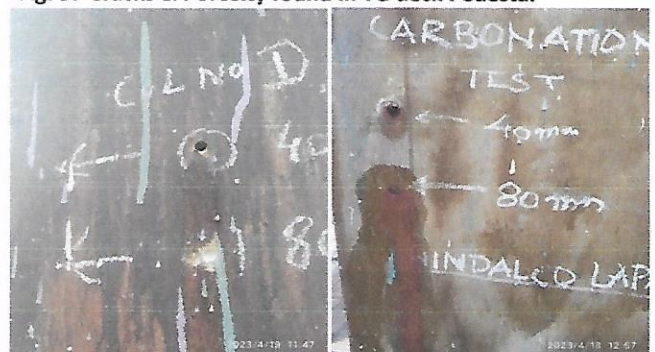
Fig. 6: RCC Columns Carbonation 40mm & 80mm Depth

The concrete is carbonated upto and beyond the level of reinforcement, according to the pH and potential data values.

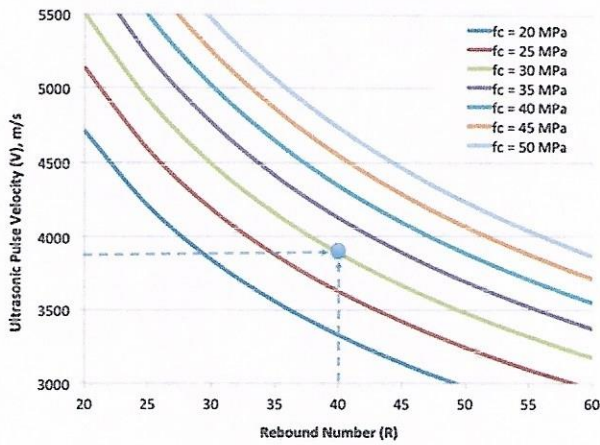
The concrete's compressive strength curves as determined by ultrasonic pulse velocity testing in conjunction with rebound hammer testing .

Fig. 7 : Graphical representation of SonReb model for evaluating Strength :

From this figure, the compressive strength corresponding to any values of Velocity and Rebound Number can be evaluated.
