ASSESSMENT OF GROUNDWATER QUALITY AROUND A DUMPING SITE IN IBADAN

Oladiran, G.F*, Raheem, S.B*, Adeniran, A.A*, Olasoji, S.O**

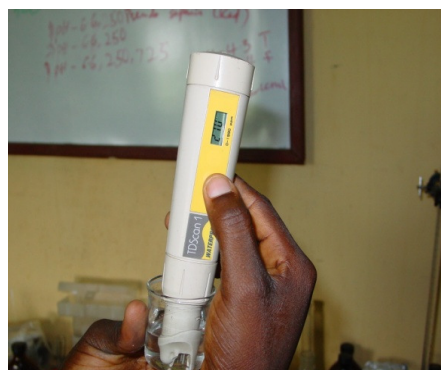
Plate 1: TDS meter reading

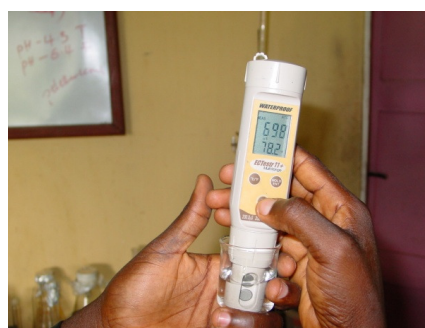
Plate 2: EC meter reading
