Accelerated Internal Corrosion in a Fresh Water Carbon Steel Pipeline Due to Intermittent Seawater Intrusion: Failure Analysis and Integrity Implications

Dr. Vijesh Vijayan

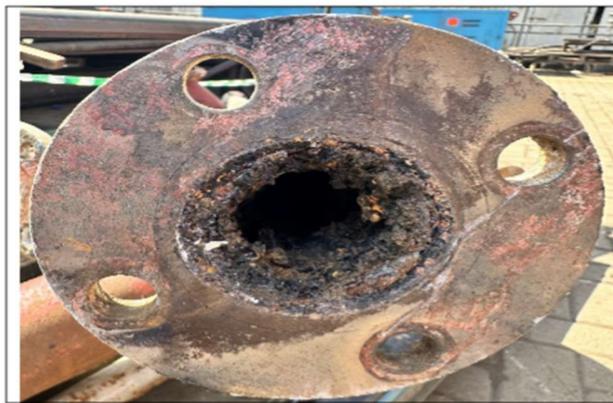
Internal bore inspection revealed extensive tuberculation and severe obstruction of the flow passage. Large nodular corrosion products projecting inward from the pipe wall were observed, resulting in substantial reduction of the effective hydraulic diameter, as shown in **Figure 1**. The corrosion morphology exhibited a layered and porous structure typical of oxygen-driven corrosion under deposit conditions.

Figure 1. Internal bore condition showing extensive tuberculation and severe reduction of effective flow diameter due to corrosion product accumulation.

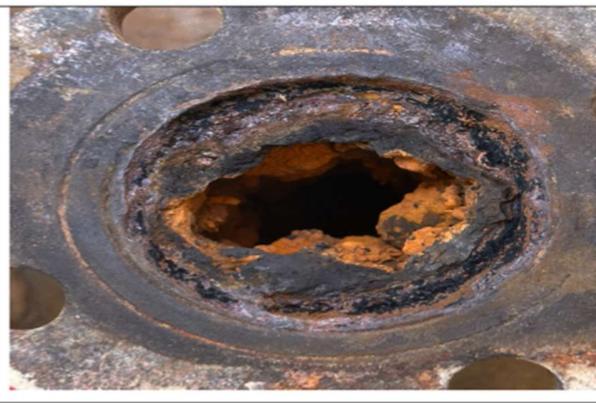
Localized concentration of attack was observed at flange bore interfaces and circumferential regions adjacent to gasket seating areas **Figure 2**. These regions displayed irregular penetration geometry consistent with crevice-enhanced corrosion and differential aeration cell development.

Figure 2. Flange bore region exhibiting localized penetration and circumferential corrosion consistent with crevice-enhanced attack.

Corrosion severity was markedly intensified at flange bore interfaces and adjacent gasket seating regions. Macroscopic examination revealed preferential metal loss in these geometrically discontinuous zones relative to straight pipe sections. The degradation exhibited circumferential concentration around the internal flange bore, with corrosion products densely accumulated at the pipe

flange transition. Upon partial removal of deposits, deep localized penetration was observed beneath consolidated corrosion products. The morphology was irregular and crevice-like, characterized by sharply defined pit boundaries and directional propagation along the flange interface.

Such degradation is consistent with stagnant flow development and restricted mass transport conditions inherent to flanged geometries. Gasket compression and micro-crevice formation at the bore interface promote the establishment of differential aeration cells. Oxygen concentration gradients between exposed bore surfaces and shielded crevice regions generate localized anodic activity within occluded zones. Intermittent seawater exposure likely introduced chlorides and marine microorganisms into these partially shielded regions, where chloride accumulation lowered local pH and destabilized semi-protective oxide films. Once corrosion deposits formed within the crevice, they stabilized the oxygen gradient and sustained under-deposit corrosion kinetics. The flange region therefore acted as a preferential corrosion initiation site due to the combined influence of

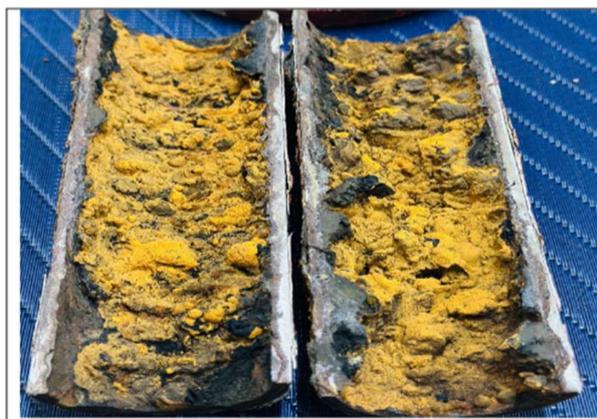
To facilitate complete evaluation, the spool was longitudinally sectioned into two symmetrical halves using mechanical cutting. The cross-sectional exposure revealed extensive corrosion product accumulation occupying

a major portion of the internal volume, as presented in **Figure 3**. The corrosion scale exhibited heterogeneous coloration, ranging from dark magnetite-like regions to voluminous orange-brown oxide deposits, indicating variable oxygen availability during formation.

Figure 3. Longitudinally sectioned spool revealing massive internal oxide buildup and cross-sectional obstruction.

The cross-sectional analysis confirmed that corrosion products occupied a substantial portion of the internal flow area. In several regions, deposit thickness approached or exceeded 50% of the original wall thickness.

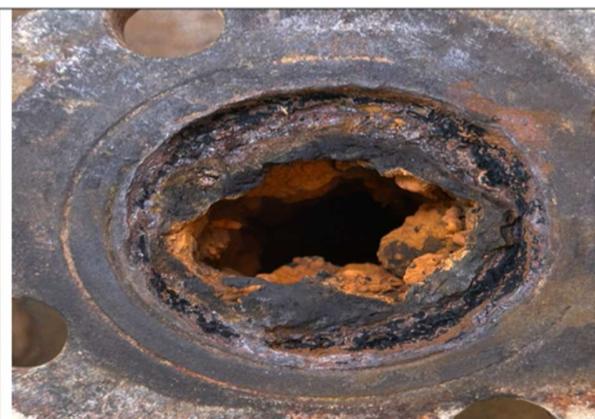
Partial removal of corrosion products in selected zones exposed deep under-deposit pitting with sharp cavity profiles and localized wall penetration, as illustrated in **Figure 4**. The pit morphology confirms concentrated anodic dissolution beneath stabilized tubercles, characteristic of differential aeration and microbiologically influenced corrosion mechanisms.

Figure 4. Under-deposit pitting morphology exposed after partial removal of corrosion products.

Following controlled partial removal of corrosion products, pronounced localized penetration was observed beneath consolidated tubercular deposits. The exposed metal surface revealed discrete pit cavities distributed non-uniformly across the internal bore. The pit morphology was characterized by irregular cavity geometry, sharply defined boundaries, and localized depth progression relative to adjacent areas. The base of several pits

exhibited directional growth consistent with sustained anodic dissolution under occluded conditions. No evidence of uniform surface thinning was observed in these regions; degradation was confined to localized attack beneath stabilized deposits.

This morphology is characteristic of under-deposit corrosion driven by differential aeration effects. Accumulation of corrosion products creates a partially shielded microenvironment in which oxygen concentration beneath the deposit becomes depleted relative to surrounding exposed surfaces. This establishes an oxygen concentration cell in which the occluded region functions as the anodic site while adjacent oxygen-rich surfaces act as cathodic regions. Intermittent seawater exposure likely intensified this mechanism through chloride ingress into the deposit structure. Chloride ions penetrate and destabilize iron oxide films, promote localized breakdown of semi-protective layers, and sustain active dissolution. Within the confined deposit region, restricted mass transport facilitates acidification and metal ion accumulation, further accelerating pit propagation. The observed penetration depth and localization are therefore consistent with the combined action of differential aeration, chloride-assisted oxide destabilization, restricted electrolyte renewal, and deposit-stabilized electrochemical gradients.

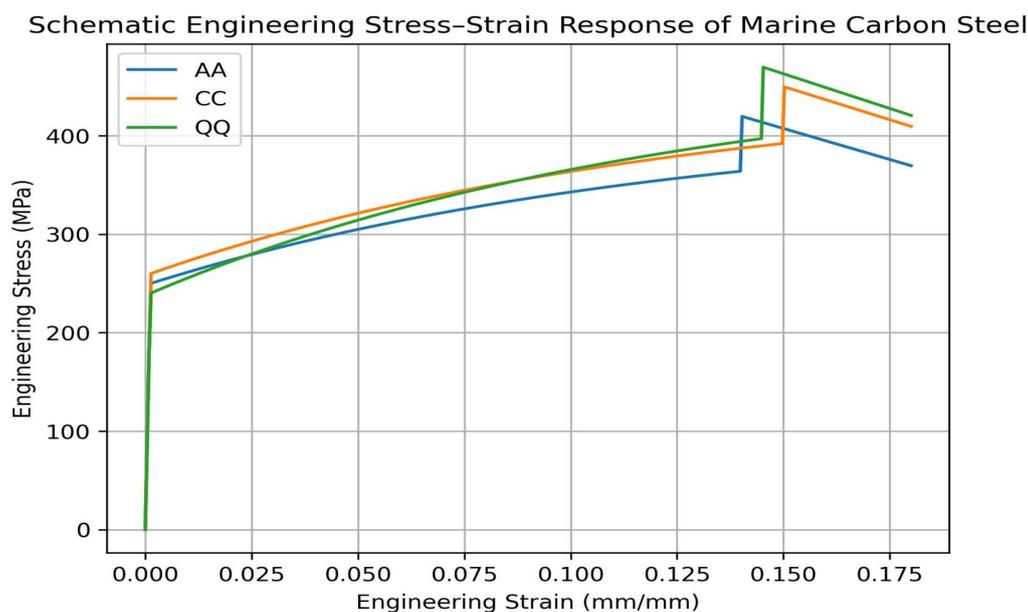
A representative schematic engineering stress-strain response for marine carbon steel is shown in Figure 5. The schematic illustrates the expected elastic–plastic transition, strain hardening behavior, and ductile failure mode consistent with ferritic microstructures.

Figure 5. Schematic engineering stress–strain response representative of low-carbon ferritic steel used in marine piping systems. Curves illustrate typical yield strength and ultimate tensile strength ranges for ASTM carbon steel grades. (Included for mechanical context; no tensile testing was conducted in this investigation.)

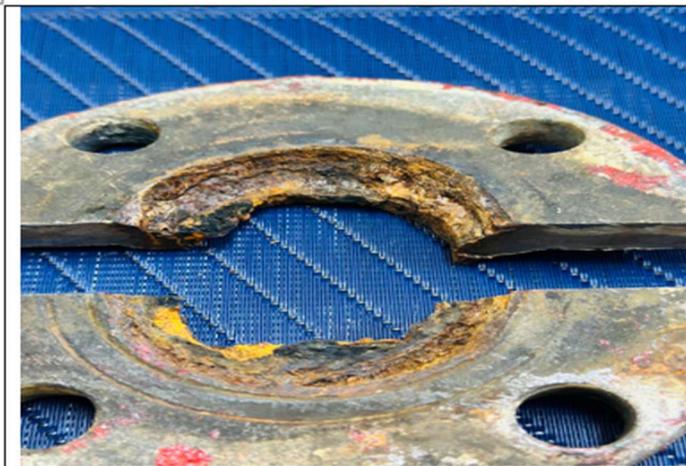
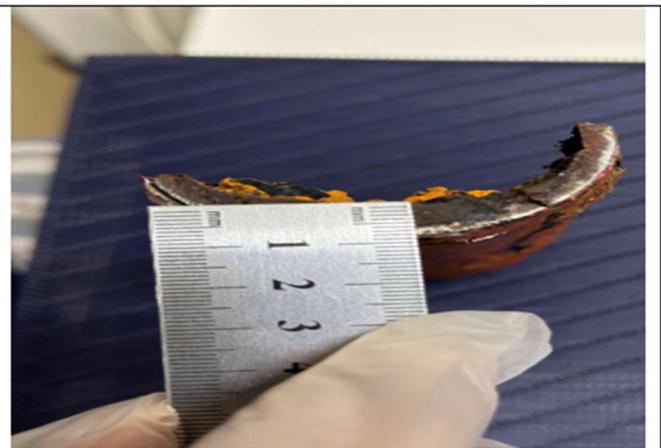
Figure 6 presents the cross-sectional morphology of the tuberculated internal surface following longitudinal sectioning of the removed spool. The image corresponds to the as-sectioned condition prior to aggressive cleaning, thereby preserving the in-situ architecture of corrosion products and the underlying metal interface.

The macrograph reveals extensive volumetric corrosion product accumulation occupying a substantial portion of the original internal diameter. The deposits exhibit a stratified structure with distinct outer and inner layers. The outer regions appear relatively porous and heterogeneous, while darker internal zones are consistent with magnetite-rich phases and lighter brown or orange regions are indicative of hydrated iron oxyhydroxides (FeOOH phases). Beneath consolidated deposits, irregular cavities extend into the steel substrate, demonstrating localized penetration rather than uniform wall thinning.

The corrosion product mass appears porous and discontinuous, capable of retaining electrolyte within occluded regions. In several locations, deposit thickness is comparable to or exceeds the remaining intact metal ligament, indicating advanced localized degradation and substantial loss of effective wall thickness. The interface between corrosion products and base metal is irregular, with penetration concentrated beneath stabilized tubercles rather than distributed evenly across the bore.

Figure 6. Flange bore cross-section showing localized attack.

Severe non-uniform metal loss is concentrated at the internal bore. Attack is confined to occluded regions and is consistent with differential aeration and chloride-assisted under-deposit corrosion.

Heavy corrosion product buildup significantly reduces the original internal diameter. Stratified deposits with porous outer FeOOH layers and darker inner magnetite-rich regions are observed. Localized cavities beneath tubercles indicate under-deposit penetration rather than uniform wall thinning.

The observed cross-sectional morphology is consistent with differential aeration beneath deposits, localized acidification within occluded electrolyte volumes, chloride retention within porous corrosion products, and sustained pit propagation. The evidence confirms that metal loss occurred predominantly beneath consolidated tubercles rather than through generalized corrosion across the internal surface.
