Degradation of Rail Track RCC Foundation of Stacker Reclaimer in Coal handling plant- A Case Study

Central Power Research Institute, Thermal Research Centre, Nagpur, Maharashtra

Diagnostic study was carried out to assess the severity of the old RCC rail track foundation of stacker-reclaimer in Captive Power Plant,Angul,Odisha

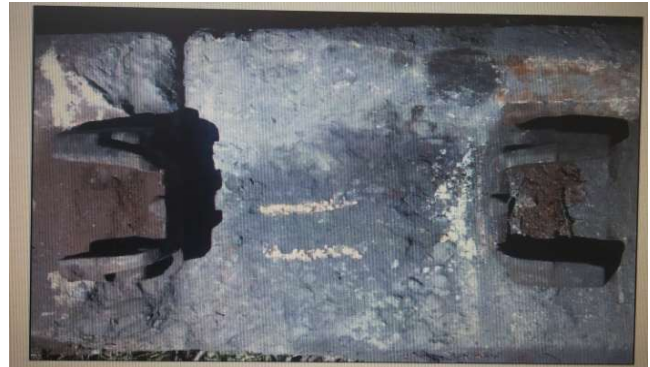
Figure 2.7 Example of concrete-tie rail seat deterioration (RSD)

Fig.1 An illustration of the degradation of a concrete-tie rail seat

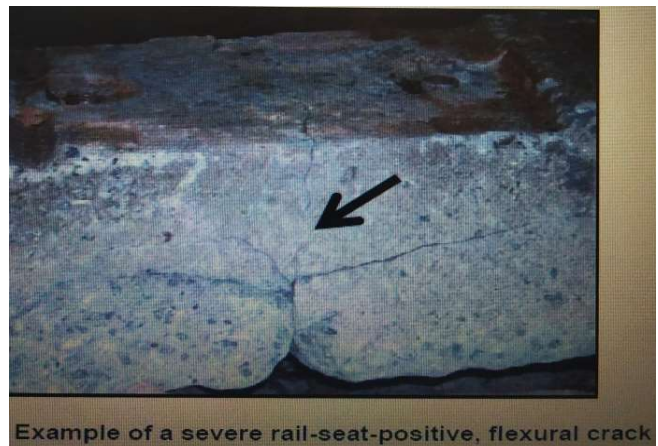
Example of a severe rail-seat-positive, flexural crack

Fig.2 An illustration of a severe, flexural, rail-seat-positive crack

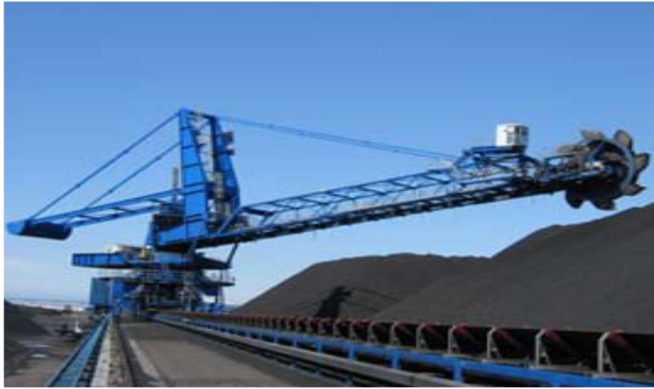
Fundamentals of Function: Two parallel stockpiles, one on each side of the train rails, can be served by the rail-mounted stacker/reclaimer. The device is made to work with a reversible yard conveyor, which stacks and discharges at identical ends while reclaiming.

Fig 4: Stacker cum reclaimer in coal yard

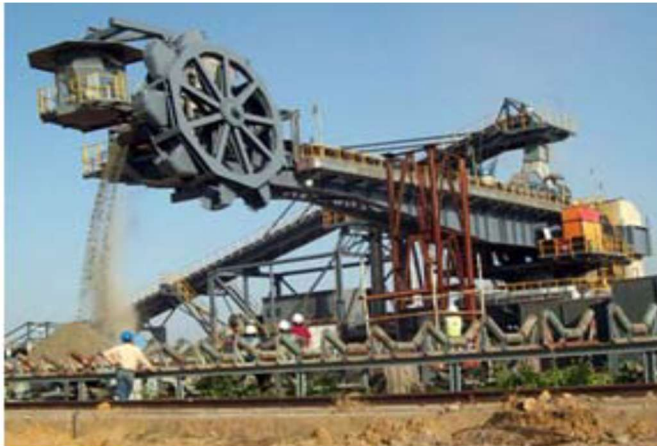
It is possible to operate in the following modes:
Stacking: The tripper raises the material on the forward moving yard conveyor, which is then released via a discharge guide chute onto an intermediate inclined conveyor. Another chute then lifts the material and finally discharges it onto the boom conveyor. The material is carried to its end by the boom conveyor, which then lets it drop from a stockpile.

Fig. 5: Stacking operation

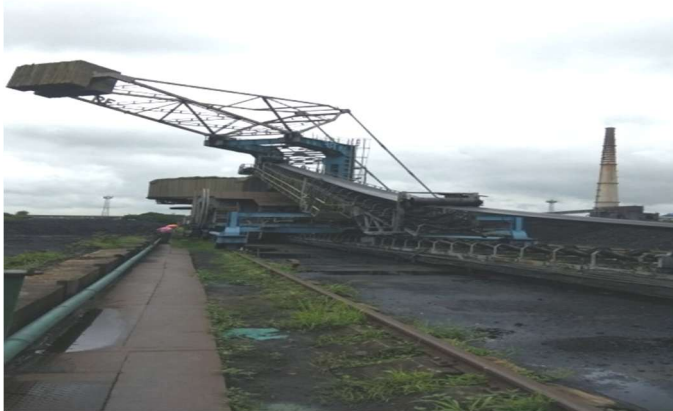
Fig.6: Photographic view of stacker-reclaimer RCC Foundation identified for testing

The schematic structure of old stacker reclaimer foundation consist of Assembling of two rails placed parallel to each other for forward and downward movement of Stacker reclaimer unit.

In between the two rails, Coal Conveyor Belt is running for coal feeding to Coal Bunkers.

Below the rail tracks, RCC beams were laid across the rail to support the track.

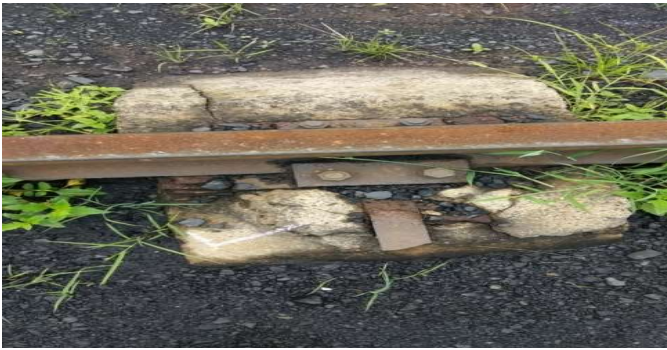
Fig. 7: Disintegration of rail track concrete

The Visual observation indicates that the rail track foundation is degraded.

The durability of concrete of rail track RCC foundation certainly can be increased using high strength concrete M₂₅-M₃₀ and the ageing affect can be minimized if poured under controlled condition

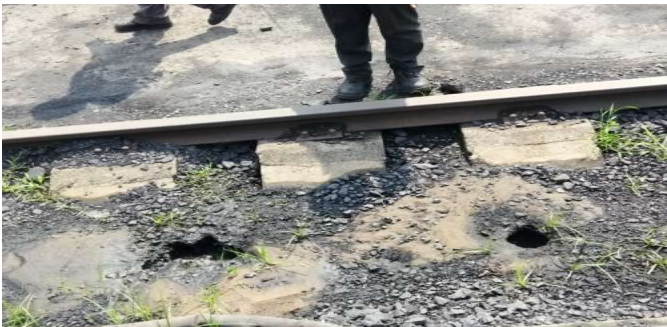
The Visual Inspection also indicates that the condition of filler material in between rail bottom and the foundation is very poor at most of places. The filler material is subjected to cracks and delaminations and separated from the main foundation. The water lodging and growth of huge vegetation is observed adjacent to rail track which may lead to percolation of water in to the consolidated soil mass causing unequal settlement of foundation.

Fig. 8: Formation of holes near rail track due to water percolation of Fire hydrant

The alignment and leveling of rail track, maintenance of proper drainage system, availability of ballast underneath the rail track shall be ascertained before movement of the Stacker/reclaimer. In addition to this, it is a matter of great concern to ascertain the condition of spikes/bolts/fishplate/weld joints provided for holding the rail track to prevent the occurrence of failure of rail track stacker reclaimer assembly. The continuity, verticality of bolts, alignment of bolts are the major important parameters for anchoring the rail track assembly which needs to be observed by the Plant authorities from a durability perspective.

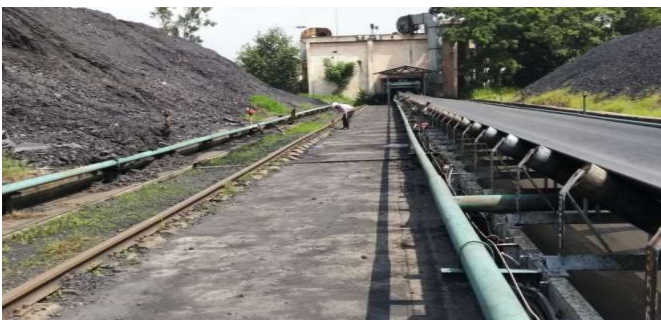
The alignment of rail track near idler frame 381-385 is totally disturbed both in vertical/horizontal direction; sinking, deflection, twisting and sagging is observed. The anchor bolts connected to spikes holding the concrete is subjected to corrosion and erosion. The M.S. spike plates holding rail bottom and the anchor plate in the filler material is extremely in poor condition due to corrosion resulting in to reduction of section

Fig. 9 : Bending & twisting of rail track

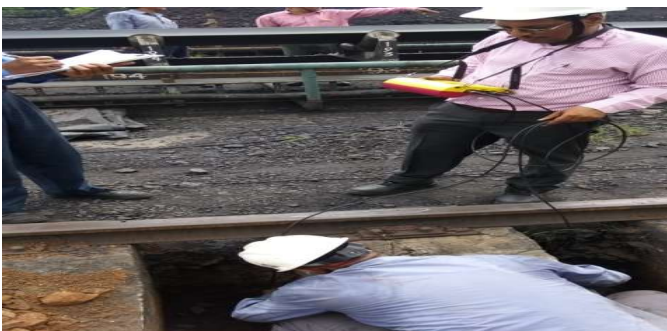
Fig.10 Ultrasonic test of rail track RCC foundation of stacker reclaimer in CHP

In the present case study, it is observed that the average value of Ultrasonic Pulse Velocity Test is between 3.1km/sec to 3.3 km/sec of RCC cross beam below the rail track which indicates that the concrete quality grading of RCC rail track foundation is moderately low in terms of soundness of the concrete as per reference standard.

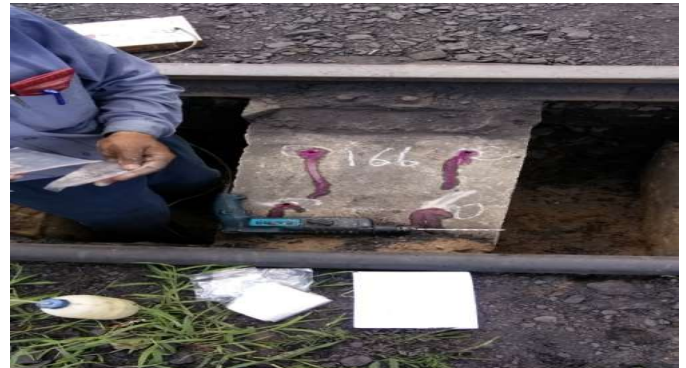
Fig.11 Carbonation test on RCC Rail track foundation of stacker reclaimer

The carbonation test performed at site indicates that the cover concrete is carbonated up to and beyond the reinforcement level in some of the RCC beams of rail track while in some beams no effect is observed.

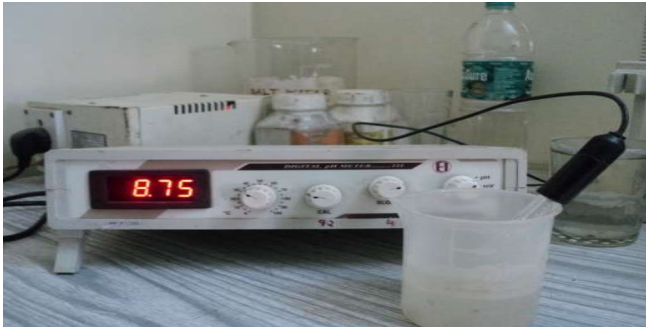
Fig. 12: pH & Potential tests of samples collected

The result of pH & Potential test carried out on the drilled hole powder samples collected from site and tested with EI make digital pH meter indicates that the pH values are below permissible limit of 13.0 indicates that the concrete is in acidic condition & embedded reinforcement is in passivity condition.
