Physicochemical Assessment of Rainwater Harvested from Rooftops in Isuikwuato Local Government Area, Abia State, Nigeria

V. U. Nkemdirim, G. N. Chima
*Department of Geography/Planning
Abia State University, Uturu*

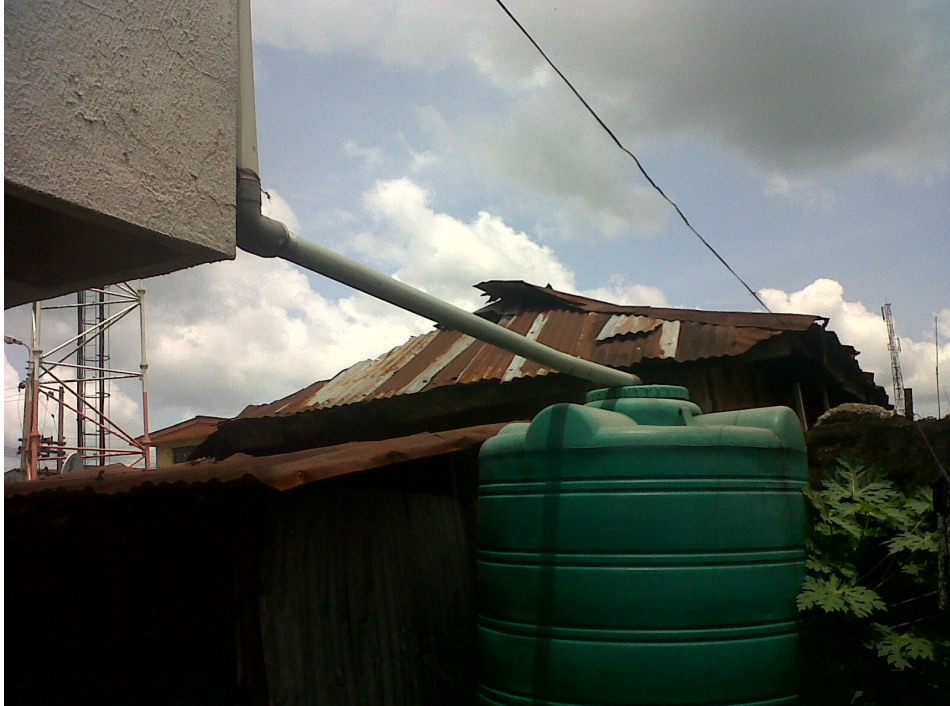
Plate 1: Rainwater harvesting channelled to ground level storage tank.

Fieldwork shows that there are two methods of roof catch or rainwater harvesting in the study areas. These are: *direct collection from roofs to containers*, and *channelling to ground level/sunken storage tanks*. In direct collection from roofs, the containers are positioned where raindrops can easily enter them. The containers used for collecting water directly from the roof include aluminium and plastic buckets, pots, basins, gourds and drums. In some cases, corrugated iron eaves are put on some parts of the edge of the corrugated iron roofs to channel water to the water containers. In the case of channelling water to ground level/sunken storage tanks, the edges of the corrugated iron roofs are eaved round (or part of it) with corrugated metals to collect and channel the rainwater to the storage tanks. Plate 1 and 2 depicts rainwater harvesting through roof catch.

These storage tanks may be made of concrete or metal. The stored water is later drawn for use when there are water shortages; some people pipe the stored water from storage tanks to their houses to provide modern piped water systems with taps, shower taps and basins, and water closets. However, there is a limit to which people of the study areas can depend on rainwater for their domestic and other activities since rainwater is seasonal, occurring between mid-March and early November. A further limit to rainfall utilization in the area is the fact that rain does not fall every day, even during the rainy season.

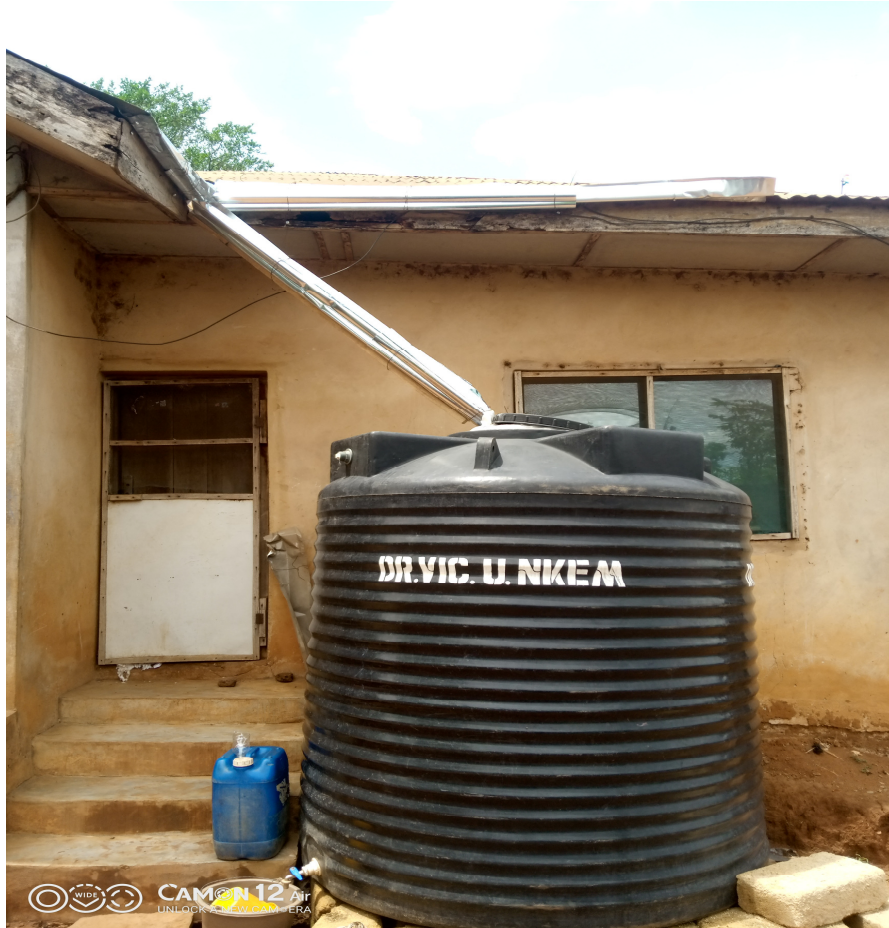
Plate 2: The edges of the corrugated iron roofs are eaved round and channelled to the storage tank.
